Stage 1/2 Road Safety Audit

The Green Quarter SHD at Cartrontroiy, Kilnafaddoge and Lissywollen, Ardnaglug (townlands), Athlone, Co. Westmeath

| Document No: | 211_035-ORS-XX-XX-RP-TR-7d-002 |

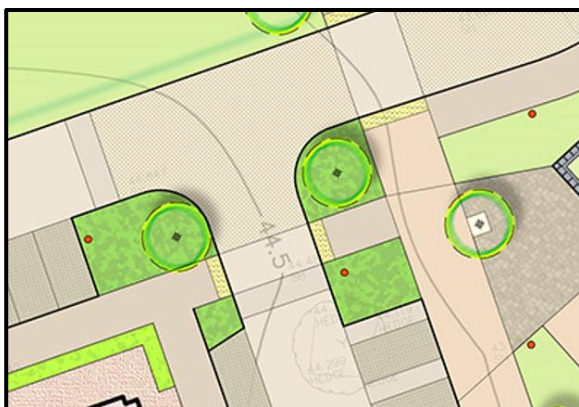
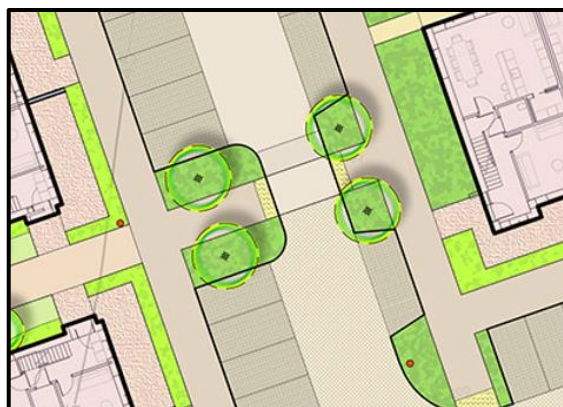
Problem No. 04: Landscaping

Location: Internal Site Layout

The audit team note from the drawings provided that the landscaping within the site may impact the visibility of road users at pedestrian crossings and internal junctions. High bushes and shrubbery should be avoided in areas where visibility is to be maintained to ensure that drivers are clearly able to see any pedestrians at designated crossing locations. This could potentially lead to instances of pedestrians-vehicle collisions resulting in injury.

The design team should ensure that any proposed landscaping does not impact visibility at junctions or along internal roads and in particular at pedestrian crossing points.
